## **ENGINEERING SPECIFICATION: ZURN Z1305**

Prod. | Dwg. No. Z1305

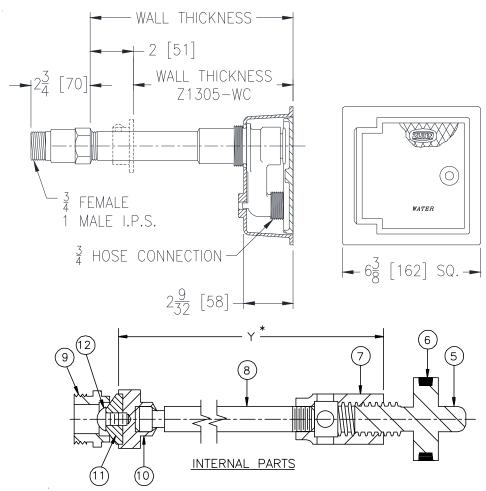
Encased, non-freeze, flush wall hydrant with bronze casing, all bronze interior parts, non-turning operating rod with free floating compression closure valve, replaceable bronze seat and seat washer, and combination 3/4" female or 1" male straight IP inlet. Nickel bronze box and hinged cover with operating key lock and "WATER" cast on cover.

<u>ltem</u>	<u>Name</u>	<u>Quan.</u>
<u>5</u>	Operating Screw	<u>1</u>
<u>6</u>	O-Ring	<u>1</u>
<u>7</u>	Operating Coupling	<u>1</u>
<u>8</u>	Operating Rod	<u>1</u>
<u>9</u>	Removable Seat	<u>1</u>
<u>10</u>	Washer Guide	<u>1</u>
<u>11</u>	Washer (neoprene)	<u>1</u>
<u>12</u>	Screw	<u>1</u>

Wall Thickness Inches [mm]	Approx. Wt. Lbs. [kg]	
6, 8 [152, 203]	11 [5]	
10, 12, 14 [254, 305, 356]	13 [6]	
16 [406]	15 [7]	
24 [508]	17 [8]
